# Hatches Level Crossing Narrative Risk Assessment

April 2022

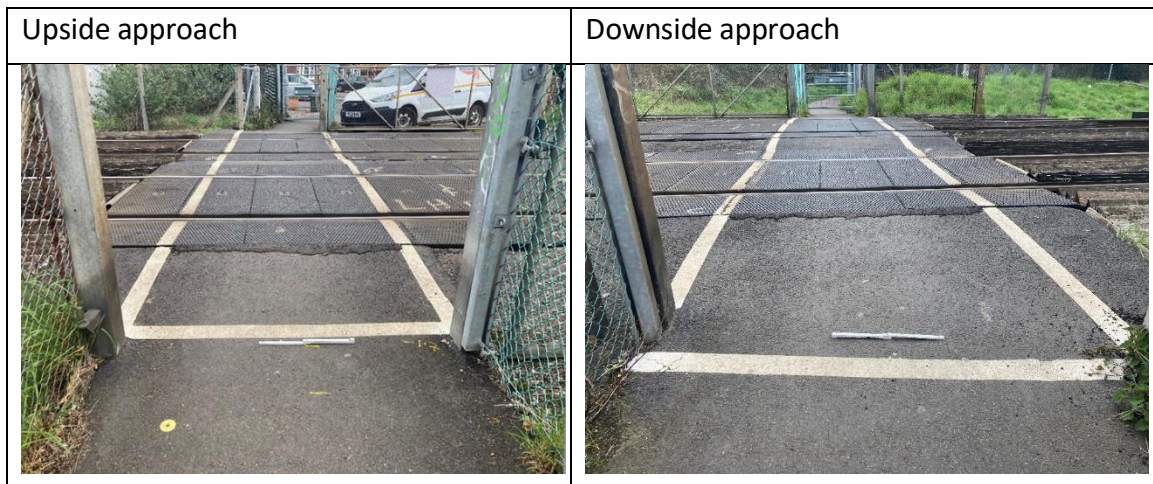
- 2.4.5 Signage Stop, look, listen signs and Danger do not touch the live rail are located at the crossing on both sides beyond the gates and before the decision point. Signage is present to encourage dog owners to keep their animals on leads, but the signs have been vandalised in the past and the LCM replaces the signs when required.

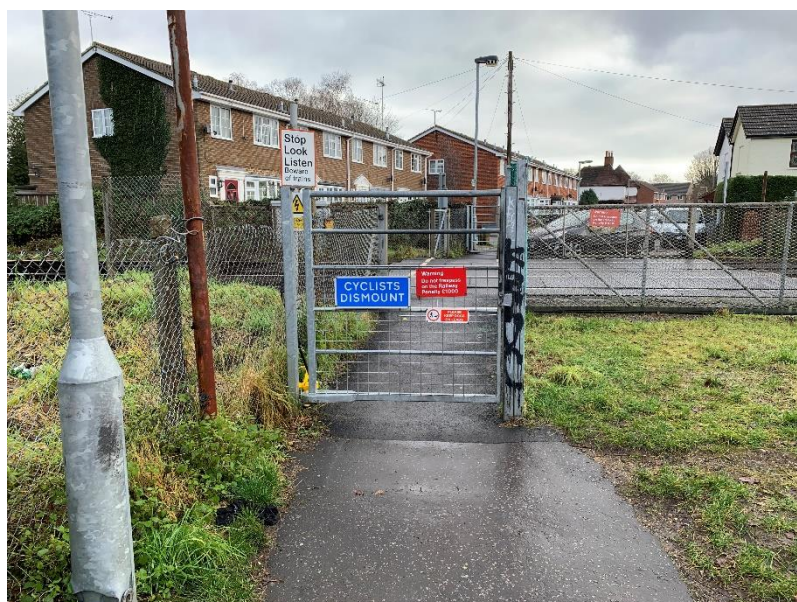
- 2.4.8 In comparison to other crossings, accidental and deliberate misuse is unacceptably high and is a regularly reported issue.
- 2.4.9 The visibility of the signs is reduced at night or at dusk with only lights from surrounding residential housing and lamp post either side of the crossing gate to illuminate the area. There are no excessive adjacent sources of light or noise that could affect a user's ability to see or hear approaching trains.
- 2.4.10 Other safety warning signs are present to highlight the electrical current (Danger do not touch the live rail), and the consequence of trespass (£1,000 fines), plus a sign requesting 'Cyclists dismount'. Further signage comprises 'Please keep dogs on leads' are also in situ but have been known to be vandalised and are replaced on the LCM inspections.

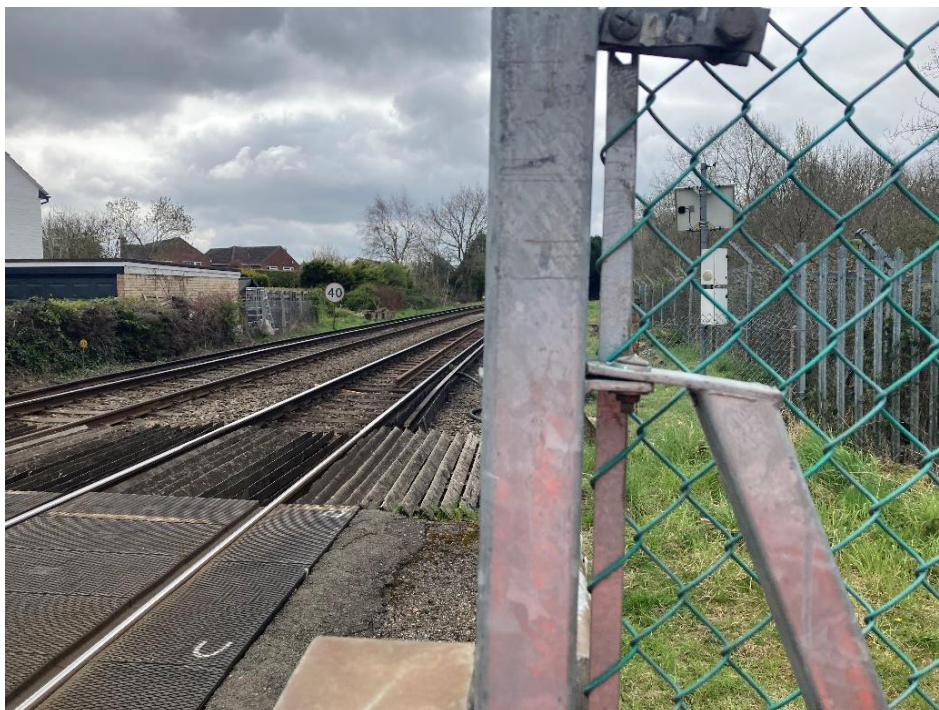
2.7.6 Upside, Up direction train approach at 2m Decision Point

- 2.7.4 The upside decision points, looking at an up-direction train approach, is obscured at 2m by at the wing fencing and the railroad access point gate. This forces a user to enter the 'danger zone' and move to approximately 1.7m from the running rail in order to achieve clearer sighting. Consideration should be given to practicability of realigning the fencing. Although the decision point has been classed at 1.7m on the upside it has been calculated at 2 meters as above.

Upside looking towards Up direction train approach	254m	321	<b>225m</b>	10.05 s	Vegetation on downside
Upside looking towards Down direction train approach	254m	321	255m	11.42s	Vegetation on downside near sighting pole
Downside looking towards Up direction train approach	254m	321	326m	14.57s	Back of whistle board
Downside looking towards Down direction train approach	254m	321	292m	13.06s	Vegetation on downside curve

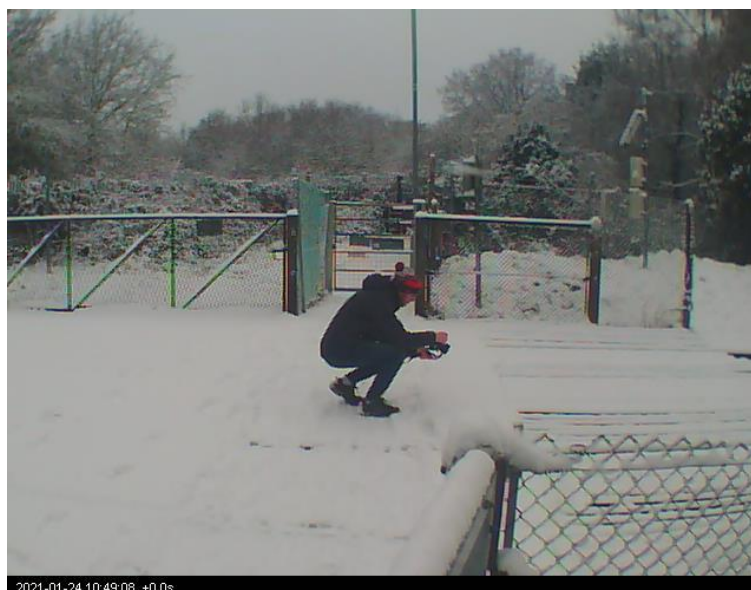
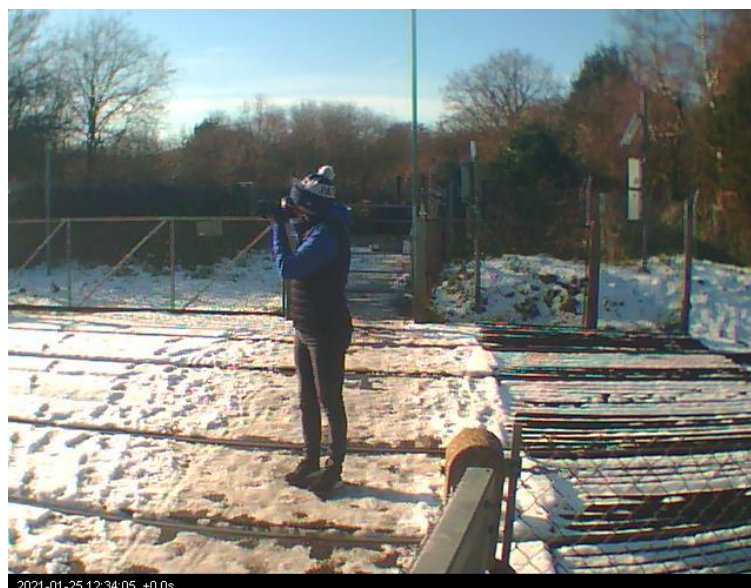
- 2.8.12 The Crossing has a history of misuse and individuals were captured during previous census taking “selfies” in the middle of the Crossing. This is not the only theme of misuse, with regular instances of runners not wanting to wait and therefore stepping into the paths of approaching trains.

- 2.8.13 Images shown below were captured at the time of the previous census.

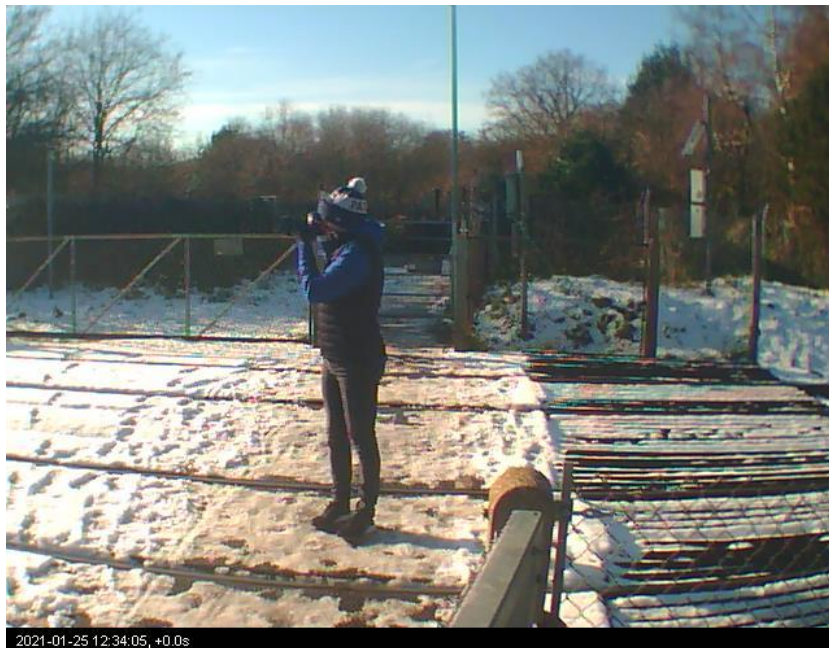
2.16.7 The above photograph taken from a census camera in January 2021 shows the Crossing in snowy weather. Although the snow has finished falling, the risk of slipping still remains. The number of footsteps indicate that Users continued to cross, and even tried to avoid the compacted snow by wandering onto the adjacent crossing surface.

2.16.8 The photograph also shows that low sunlight can often limit sighting of oncoming trains from the up direction. The direction and length of the shadow from the person shows that viewing of trains coming from the up direction could be impaired by low sun.
