# Hatches Level Crossing Narrative Risk Assessment

April 2022

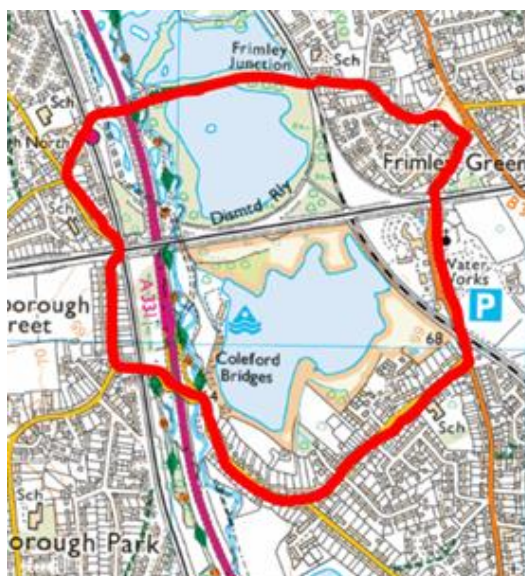
- 5.4.4 The diversionary route highlighted in red below is 2.4 miles.

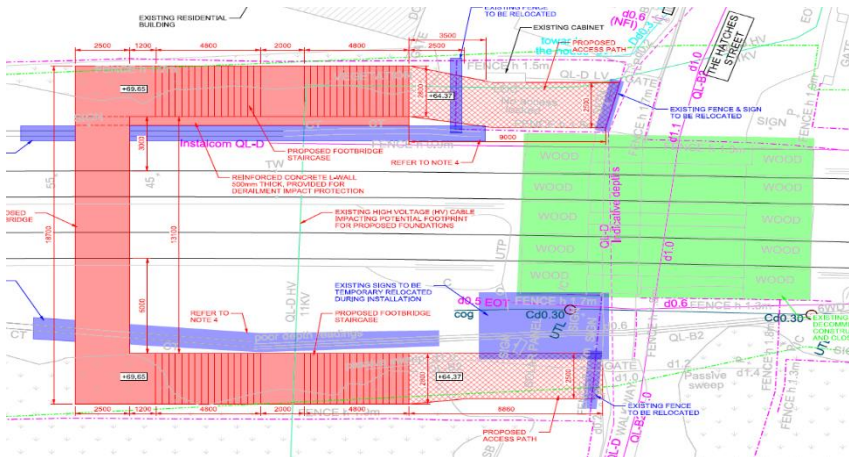
5.5.3 This option was also space constrained. The design proposed to use as much of Network Rail’s land as possible, but it would have been positioned very close to housing on the north-east corner of the Crossing, causing severe disruption and inconvenience to those residents.

5.5.4 The diagram below shows the proposal with the grey area on the top edge representing a residential property.
